## Visual and Thermal Areal Roof Inspection

Bob Williams  
000 Old St Augustine,  
Doral, FL 32222

[Integral Drone Services LLC](#)  
Justin Scheiber  
904-906-5095

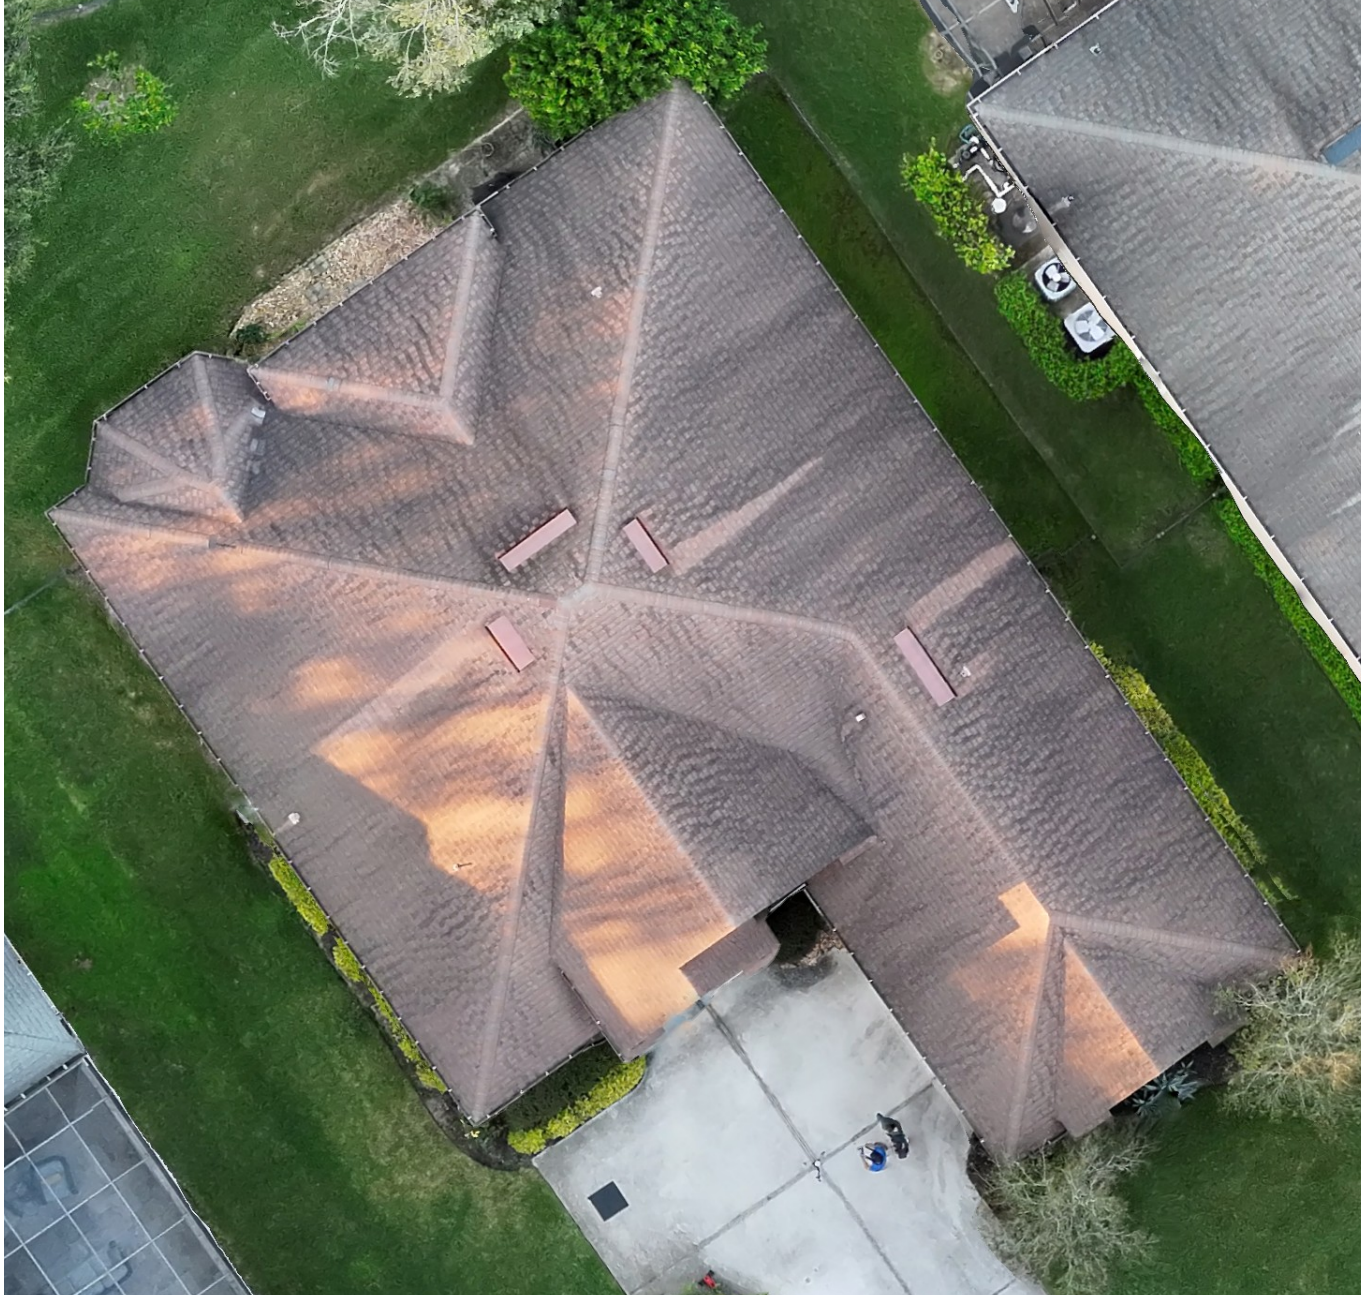
The visual analyses show 2 missing shingles from the hip on west corner of the house. Those shingles are still present in a valley above.

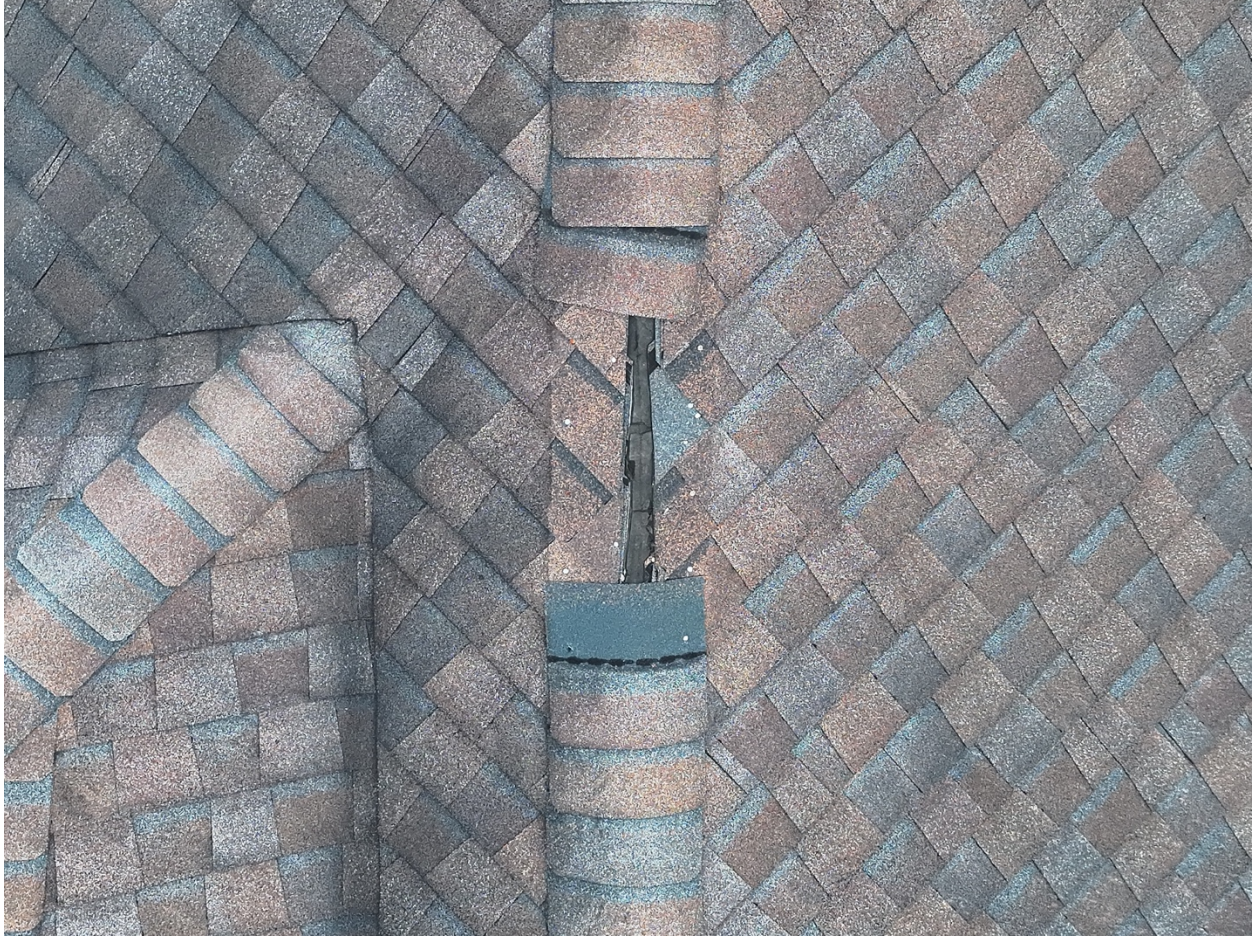
At least two missing shingles from the roof hip.

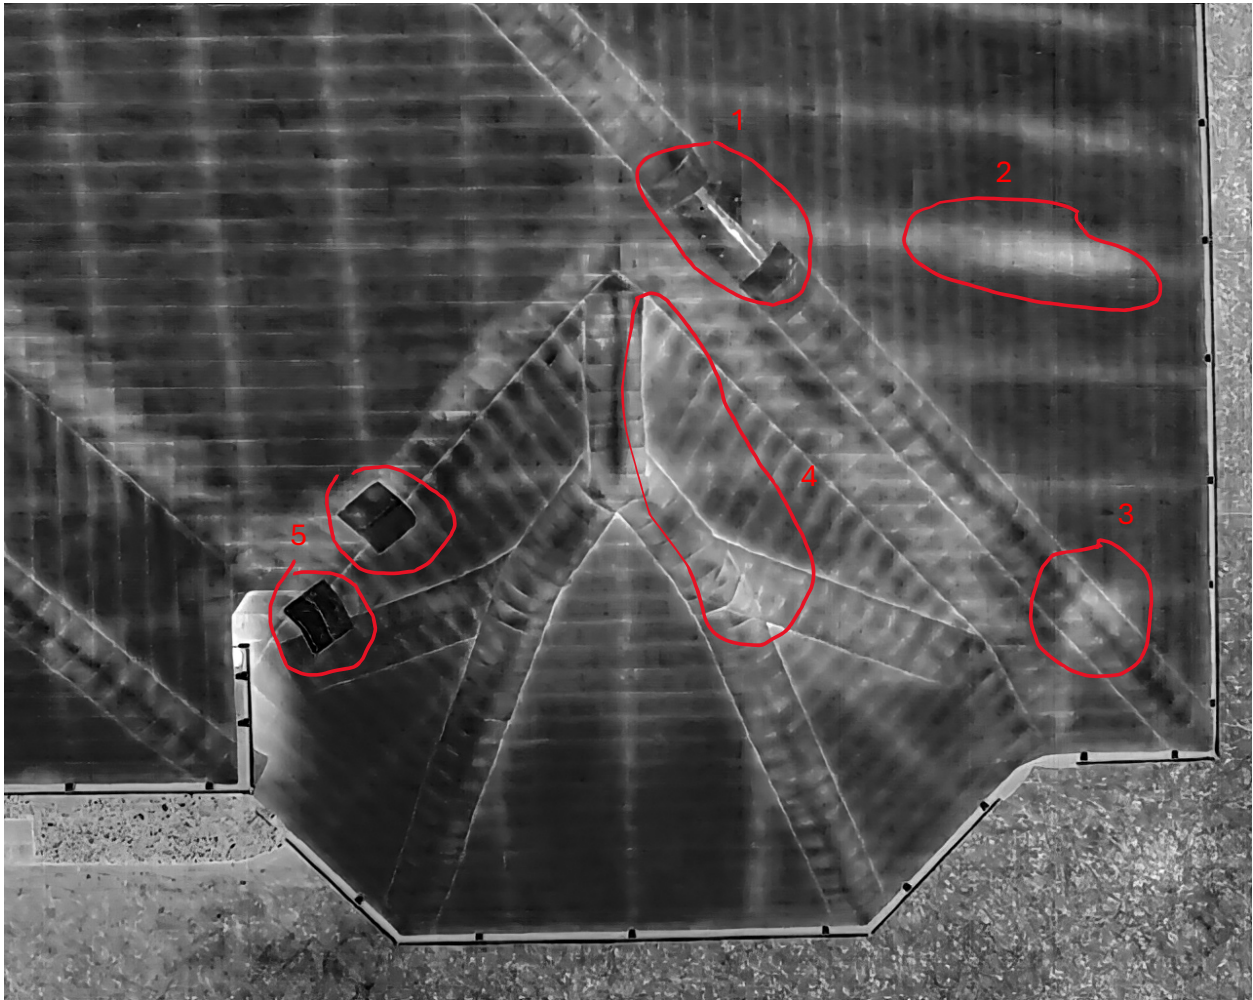
Image 1: West Corner

Shingles are missing from hip allowing water intrusion to the roof structure. The proximity of the amorphous anomalies 1 and 2 could be caused by water running down the roof structure. There is one area of concern (labeled 4) that presents warm relative to the rest of the roof.

1. Missing shingles
2. Amorphous anomaly 1
3. Amorphous anomaly 2
4. Area of concern 1

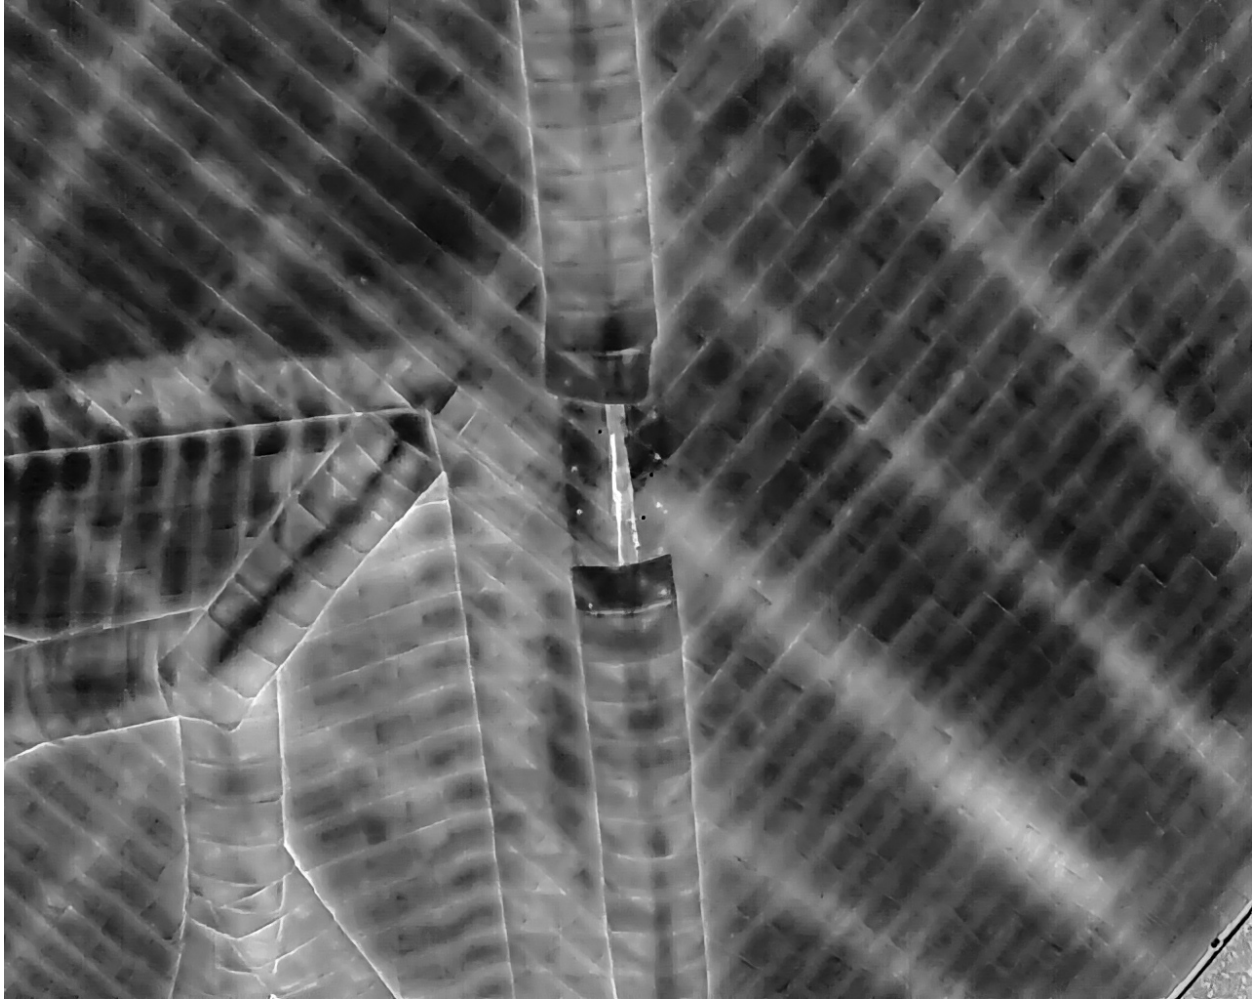
Image 1-a: West Corner closeup

A closer thermal image of the missing shingles presented in Image 1.

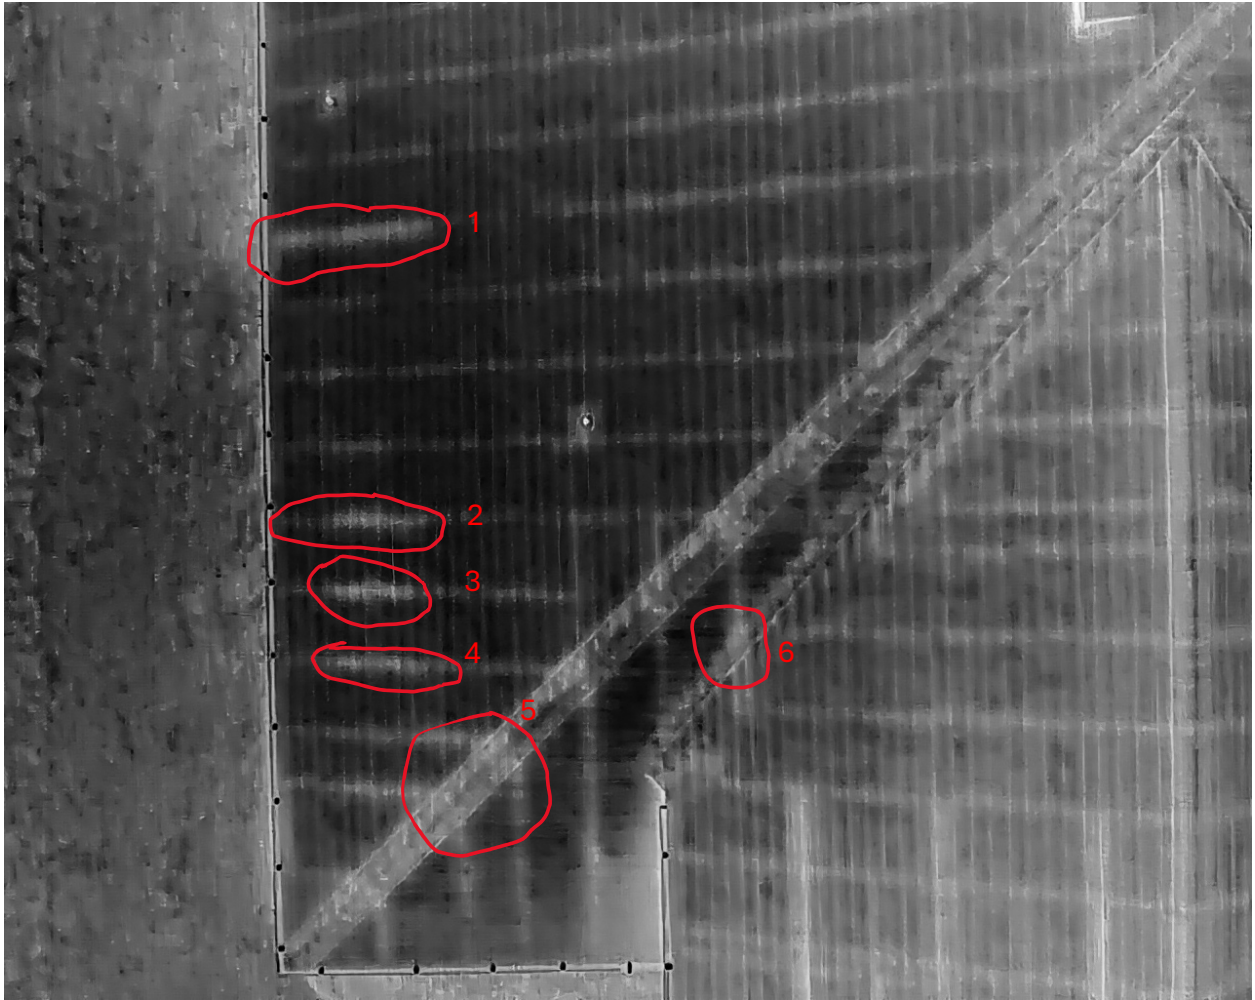
Image 2: Southwest Corner

Six thermal anomalies on the Southwest corner of the house. Thermal anomalies 1-4 are amorphous anomalies that generally follow a rafter. Thermal anomaly 5 is an area of concern. It presents hot relative to similar parts of the roof.

1. Amorphous anomaly 1
2. Amorphous anomaly 2
3. Amorphous anomaly 3
4. Amorphous anomaly 4
5. Area of concern 1
6. Amorphous anomaly 5

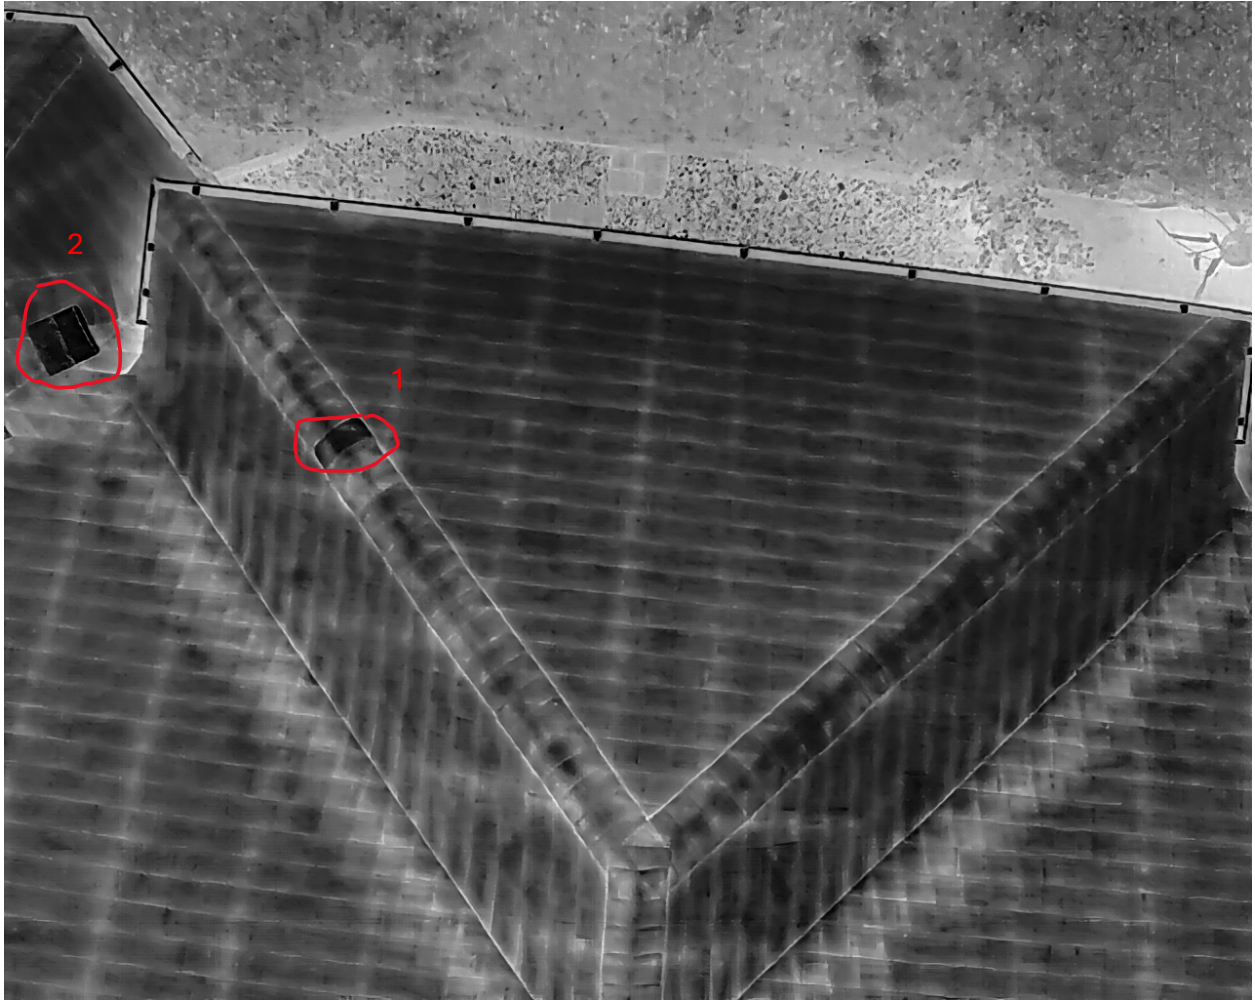
Image 3: North Wall

Two anomalies that present colder than the rest of the roof.

1. Loose shingle
2. Hip shingle
