## Visual and Thermal Areal Roof Inspection

Bob Williams  
000 Old St Augustine,  
Doral, FL 32222

[Integral Drone Services LLC](#)  
Justin Scheiber  
904-906-5095

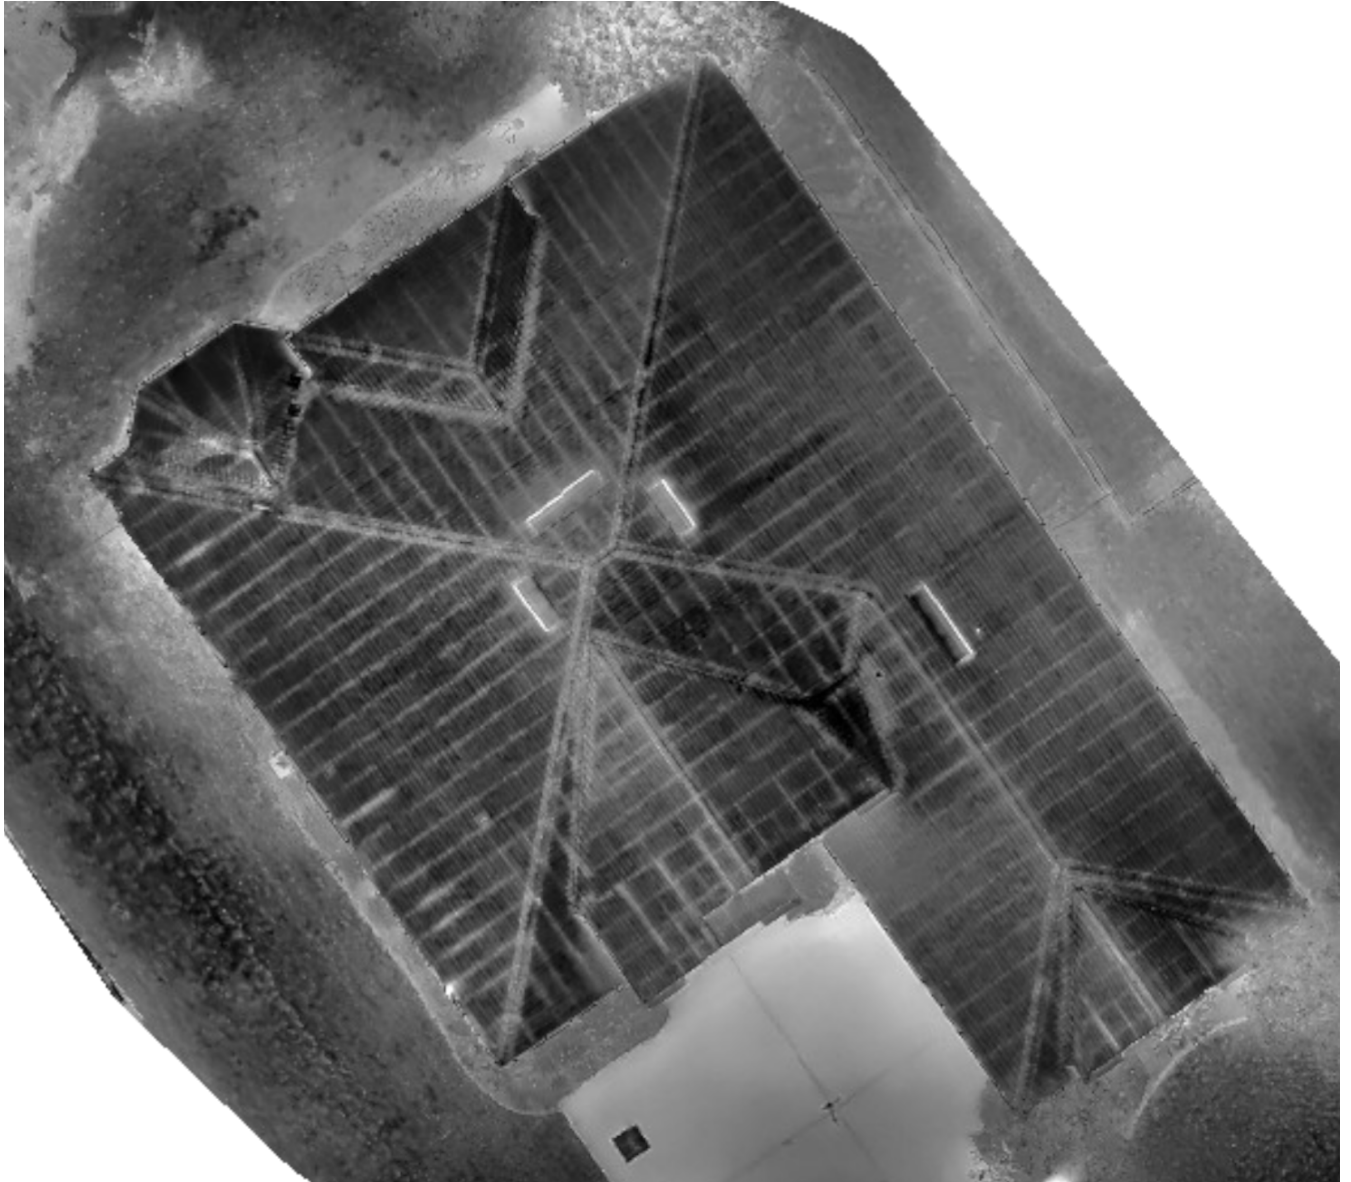
## Overview

The images below are in the white-hot palette, meaning the cooler areas are black and the hotter areas are white.
